## Service Bulletin Nº 66

TOMAY

The Who's Tommy New Ball Kicker Arm Assembly,

Part Number 515-6213-00

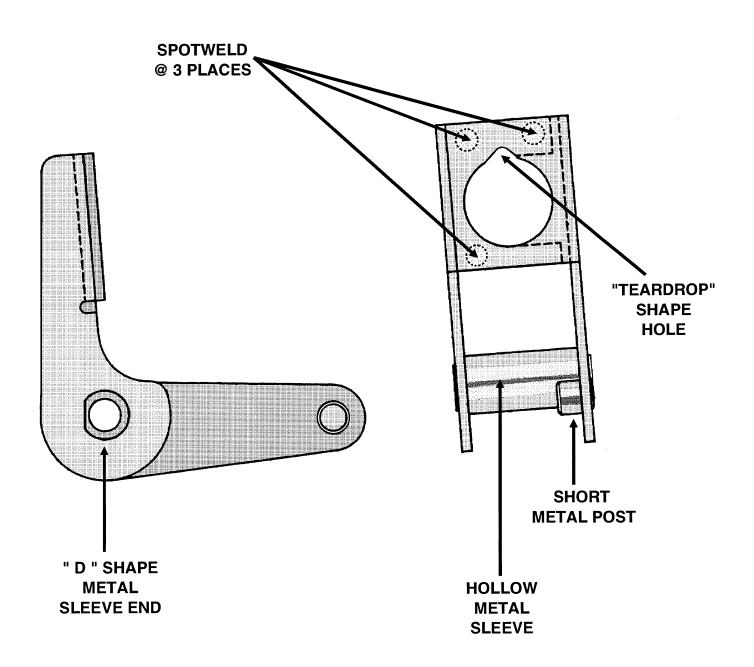
The original Ball Kicker Arm Assembly, (PN 515-5991-00), used on the Shooter / Kicker Assembly, (PN 500-5797-00), has had a higher than normal failure rate. The *kick-arm* has been breaking off directly below the striking surface resulting in part orders.

The **Hollow Metal Sleeve** is breaking free from the *kick-arm brackets*, allowing them to twist, creating a stress point below the striking surface.

Replace with the **New Ball Kicker Arm Assembly**, PN 515-6213-00. Listed below are some of the improvements we have made (refer to the diagram on the next page):

- 1) The material has been changed from cold rolled steel to stainless steel.
- 2) The width of the material behind the nibble has been increased.
- The shape of the sleeve has been changed to a "**D**" shaped sleeve to prevent slippage.
- 4) The seam welding has been eliminated and replaced with spot welding to reduce hardening of the material.
- The circular hole has been changed to a "*teardrop*" hole on the striking surface to improve accuracy and reduce stress.
