№ 125

SUBJ: Quick Tip for Display Troubleshooting:

U201 White Star Board System™

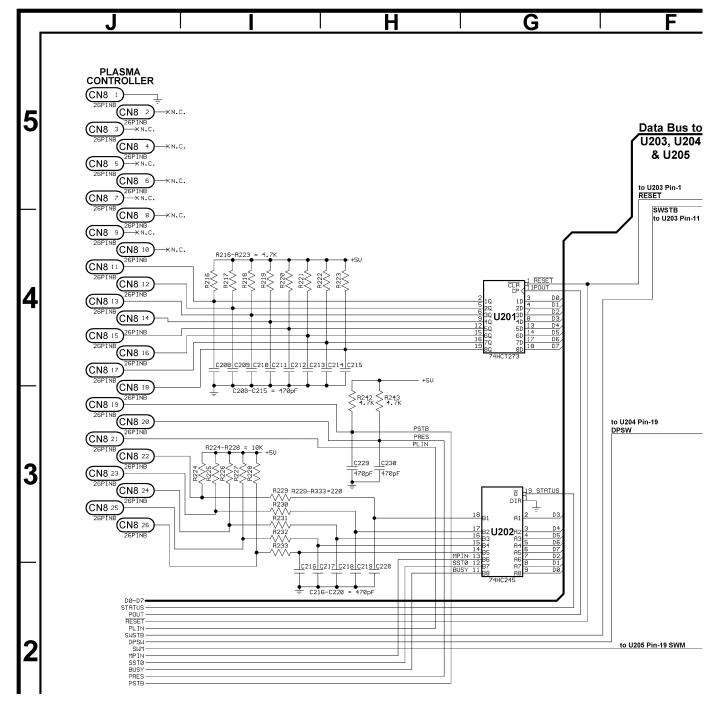
CPU/Sound Board Schematic (Sheet 3 of 3)

U201 Failed. U201 is a 74HCT273 Data Latch (see the CPU Sound Bd. pictorial, lower right).

Plasma Interface: The data path for communication to and from the Plasma Controller Board is 8 bits wide. There are separate *Input* and *Output Busses*. The *Input Bus* from the Plasma Controller to the CPU/Sound Board comes in on CN8 [PLASMA CONTROL]-Pins 3-10 and is fed into U200 for input to the CPU's *Data Bus*. Data going out to the controller comes from the CPU's *Data Bus* through U201 and onto CN8-Pins 11-18. Status back from the Plasma Controller comes in on CN8-Pins 22-26 and is fed into U202 for input to the CPU's *Data Bus*. Two control signals that go out to the Plasma Controller are PRES [PLASMA RESET] and CN8-Pin 19 [PSTB - *Plasma Strobe*]. The Plasma Reset is software controllable through U216/B and also has a test point "Plasma Reset". The *Plasma Strobe Signal* to the controller is generated from U216/A and is *used to latch data* into the Plasma Controller.

Replace U201.
