# N<sup>o</sup> 141 SERVICE BULLETIN

**SUBJ:** T3™ Shooter Lane Switch Actuator Adjustment

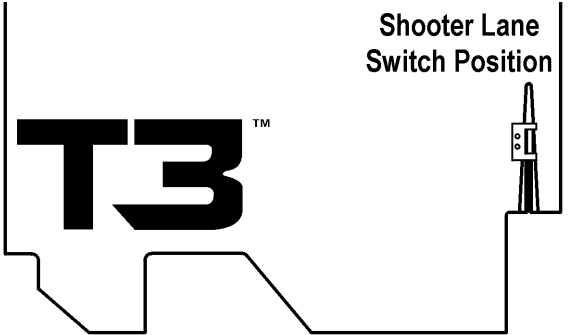
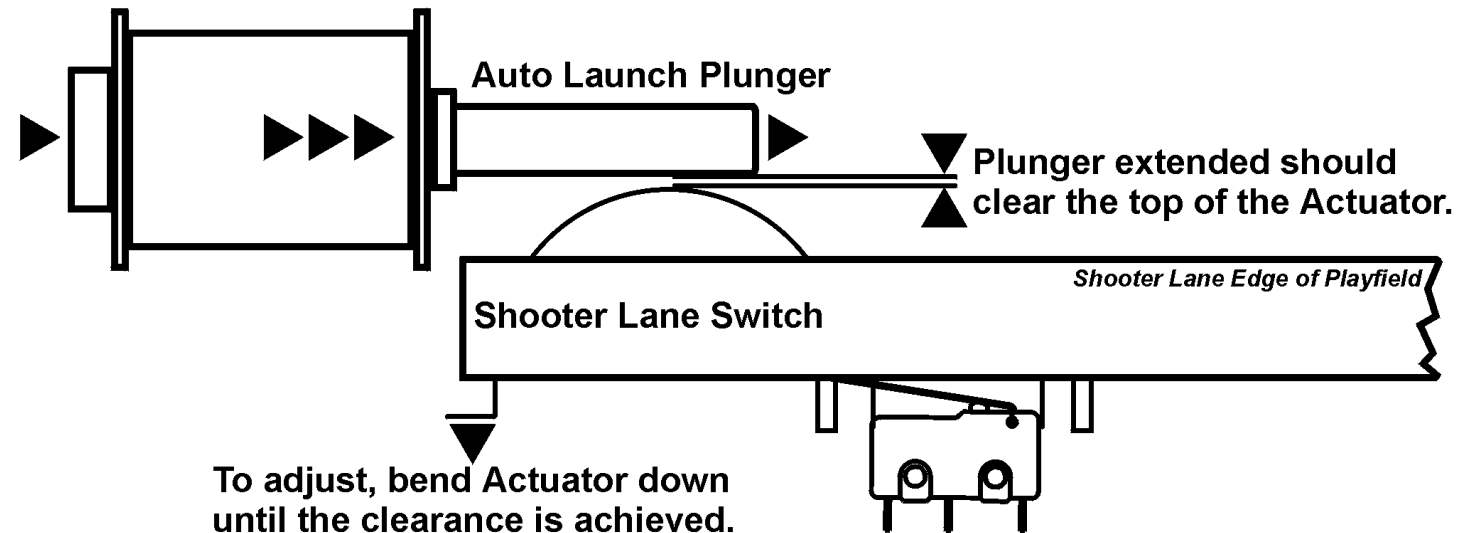
The **Auto Launch Coil** fires repeatedly causing damage to the coil and possibly the **Q2 Drive Transistor** located on the I/O Power Driver Board (*above J8 Connector, bottom right*).

The **Shooter Lane Switch Actuator** is adjusted *too high*. This makes it possible for the Auto Launch Plunger to hit the switch actuator which causes a switch closure. The **CPU** then repeatedly energizes the coil every time it reads a *Shooter Lane Switch Closure*. *The coil then overheats and may damage the Q2 Drive Transistor.*

Adjust the switch actuator down so the Auto Launch Plunger fully extended (*use finger*) will clear the top of the actuator.
